NIST NCSTAR 2: Vol. I

Report of the Technical Investigation of The Station Nightclub Fire

June 2005

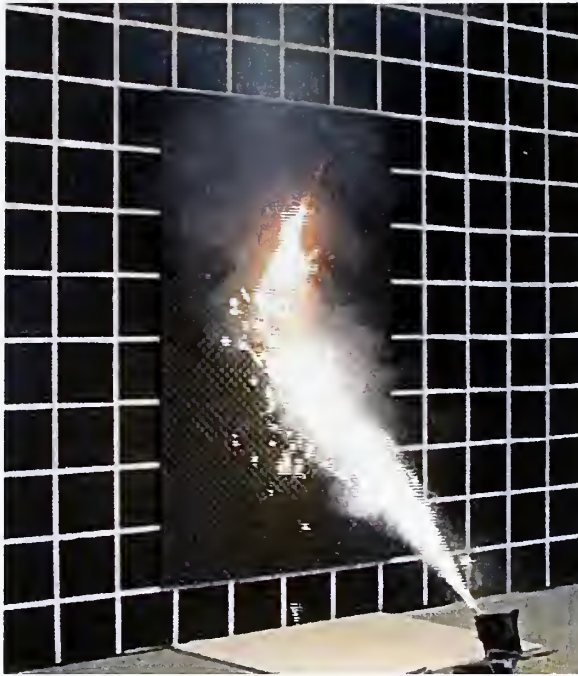
The hazard associated with the building contents was created by the close proximity of a high temperature source (a pyrotechnic device) and a substantial amount of material with a relatively low ignition energy and high flame spread rate (polyurethane foam). As could be seen in the WPRI video, flames spread rapidly over the foam, generating smoke and enough heat to ignite the wood paneling underneath and adjacent to the foam. The wood structure and paneling in the nightclub was estimated to contain over 95 percent of the fuel load, so that once most of the foam was consumed, the fire transitioned to a wood frame building fire.

Pyrotechnic device impinging on non-fire retarded polyurethane foam panel

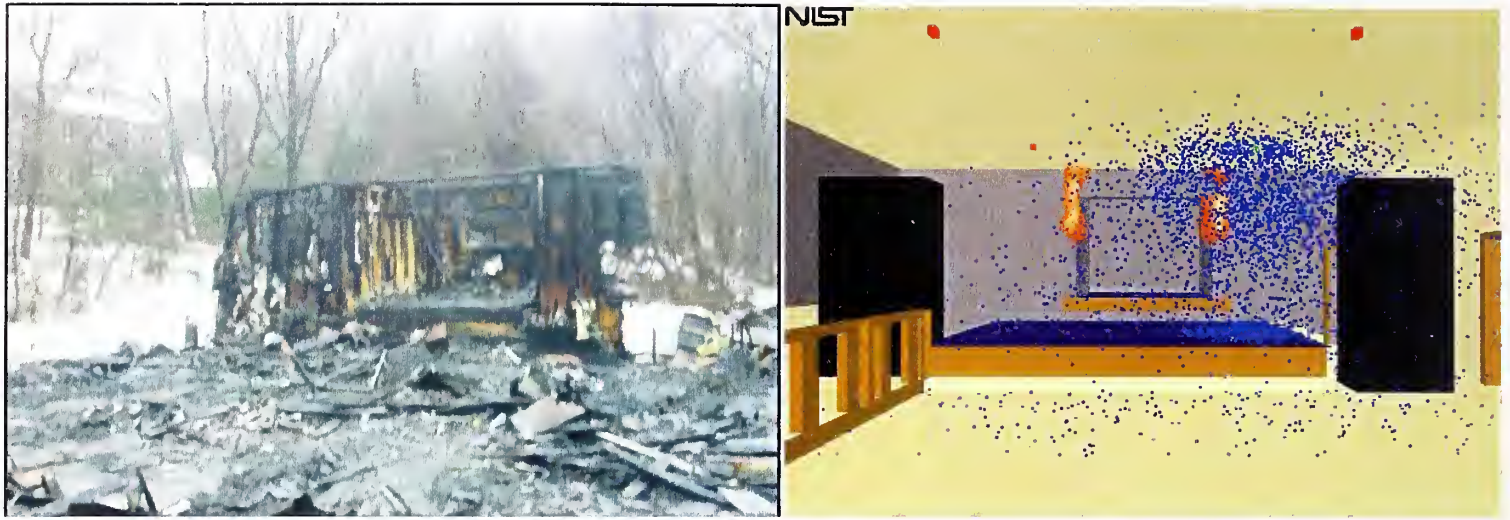
Experiments conducted at NIST in a reconstruction of the platform area fire demonstrated that a water sprinkler system installed in the test room in accordance with NFPA 13 (*Standard for the Installation of Sprinkler Systems*) was able to control the fire initiated in non-fire retarded polyurethane foam panels and to maintain survivable conditions at head height in the test room for the duration (over five minutes) of the experiment. A computer simulation of the full nightclub with and without sprinklers led to a similar positive result for the sprinklered scenario.

Remains of the platform area after the fire (left) and an image from the simulation of The Station fire had sprinklers been installed (right)

2. **Sprinklers:** NIST recommends that model codes require sprinkler systems according to NFPA 13 (*Standard for the Installation of Sprinkler Systems*), and that state and local authorities adopt and aggressively enforce this provision,

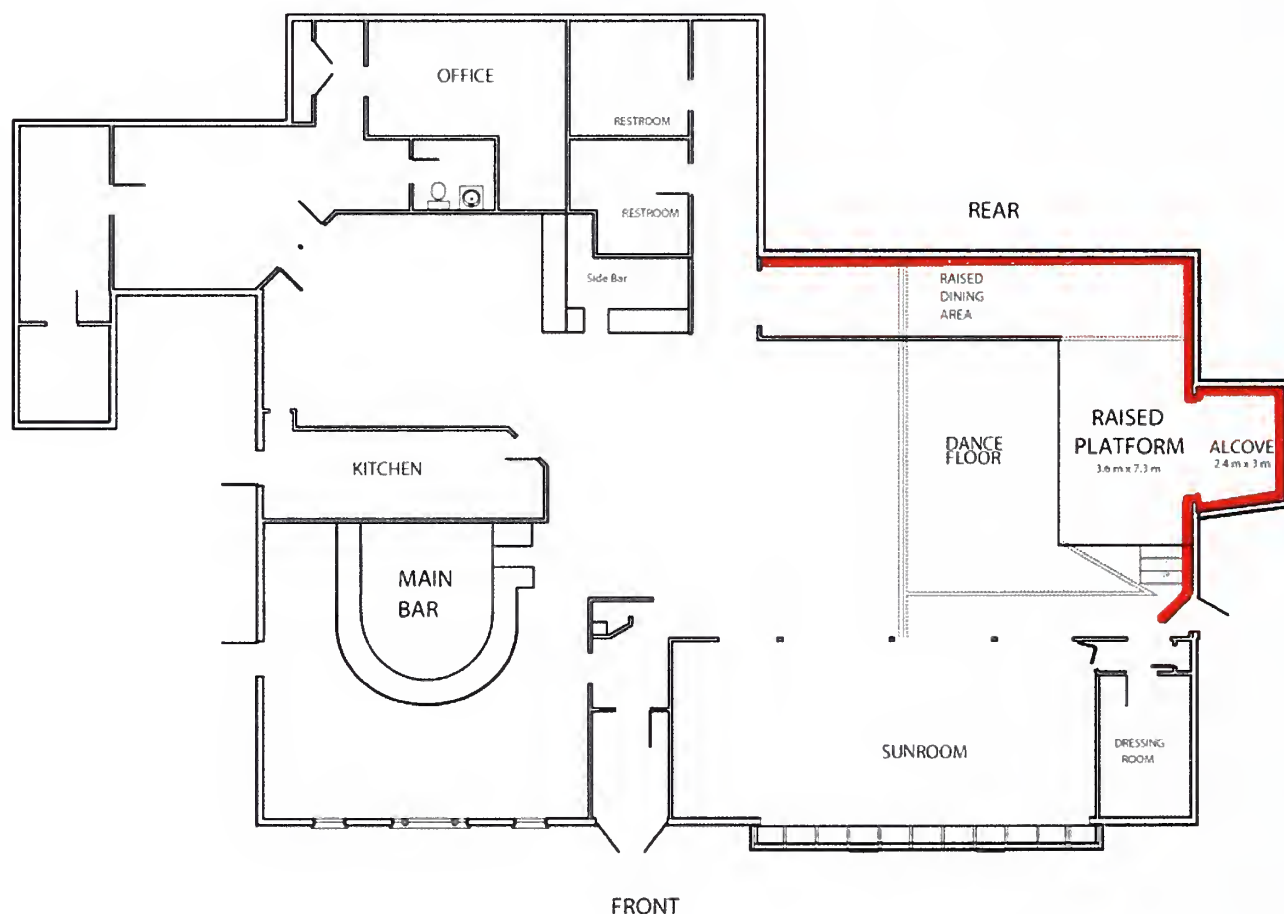
Figure 4-1. Portion of Nightclub with Polyurethane Foam Mounted on Wall (shaded red section).

The photographs of the nightclub interior do clearly show gaps where two sheets of foam meet. Gaps between the foam and the wall can also be observed at various locations, typically at external corners of the alcove. While the gray color of the foam can be observed in some photos of various bands that had performed at The Station, later photos show a darker color, indicating that the foam may have been sprayed with a black paint. The surface of the foam also had a glittery appearance that may have been a result of the wet paint being dusted with glitter or sparkle dust. Some of the glitter would have become partially embedded in the wet paint and would have provided the more sparkling appearance that was observed in some of the video of the nightclub interior.

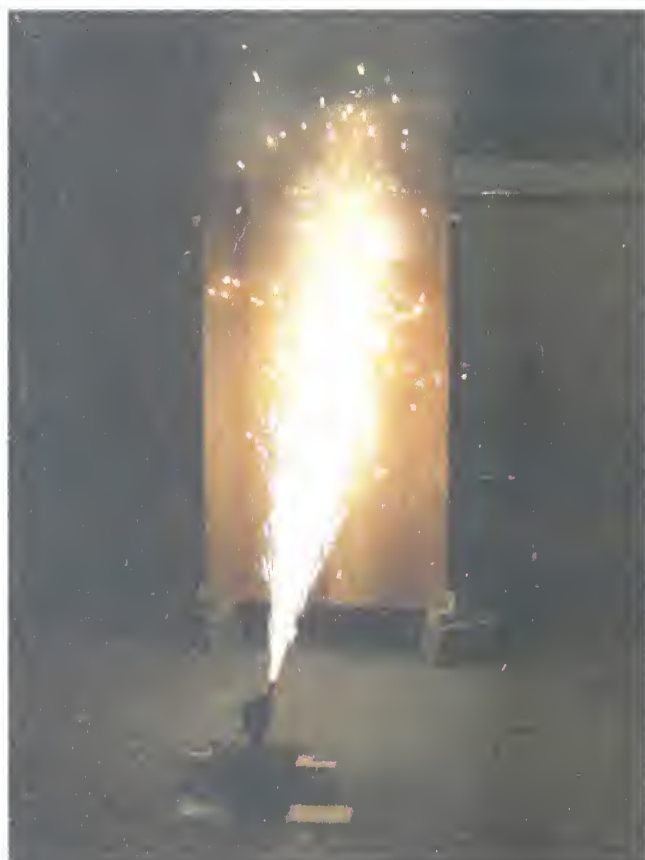
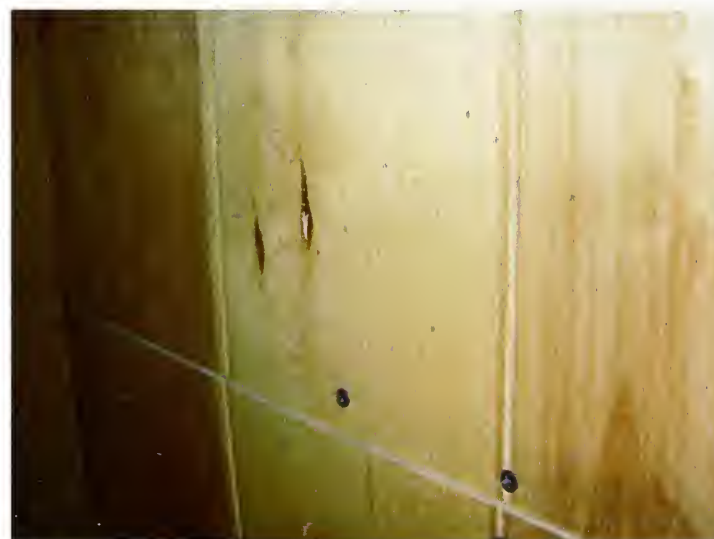
Figure 4-14a. Gerb impinging on wood panel.

Figure 4-14a shows the sparks from the gerb impinging on the wood panel about half way through the test. No ignition was observed. The hot sparks did create small black marks and craters in the finish of the panel, as can be seen in Figure 4-14b.

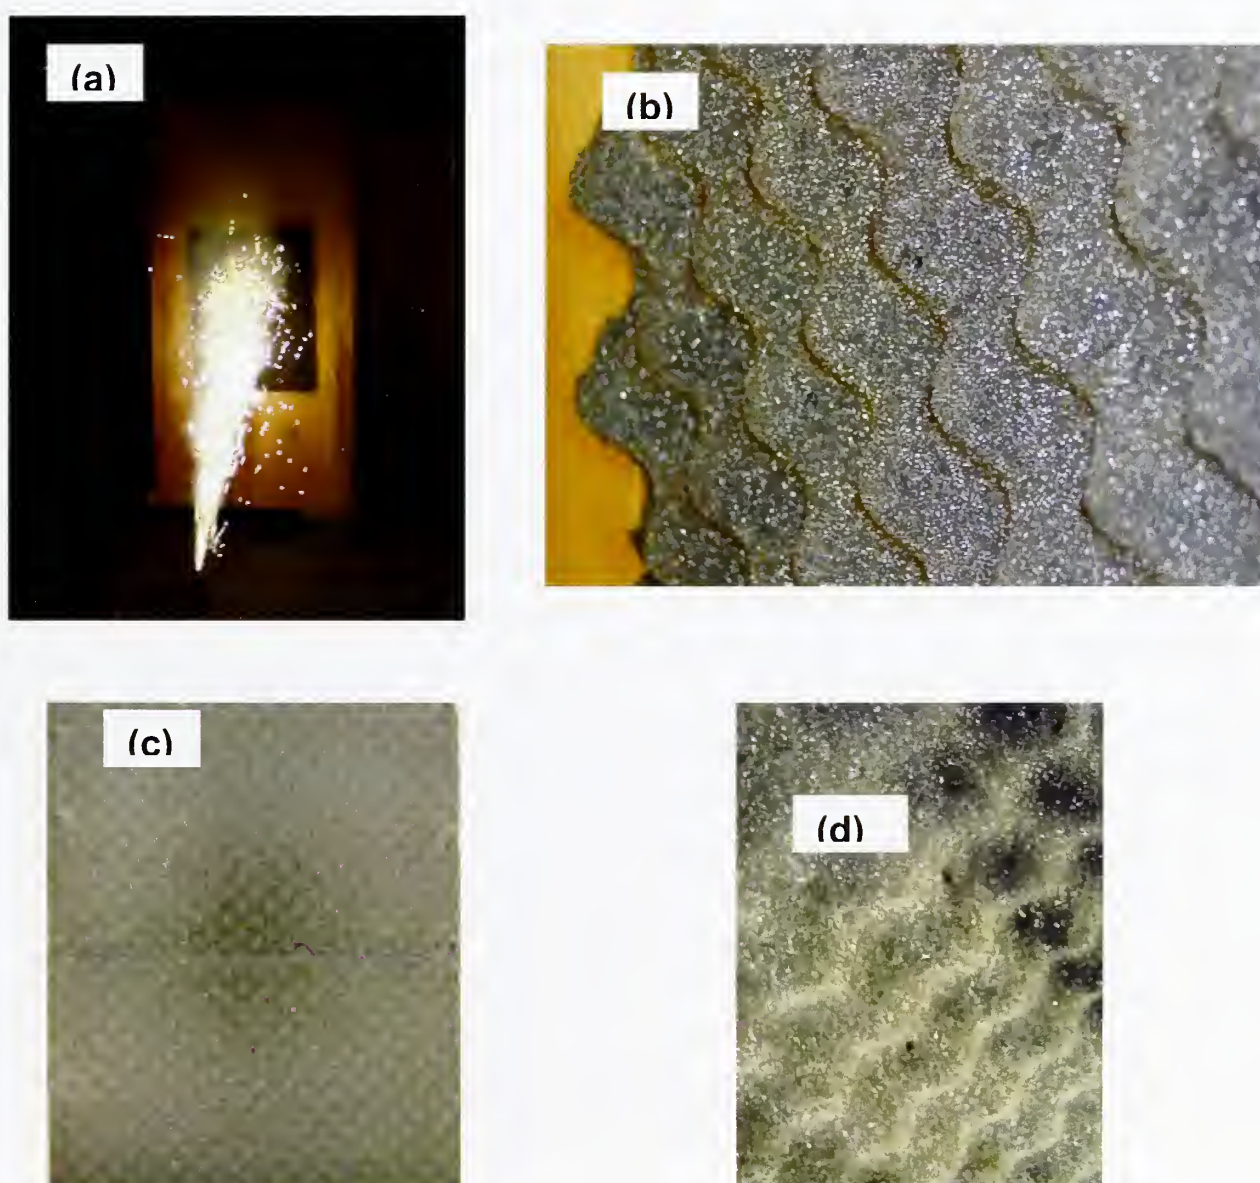
The experiment was repeated with a new piece of foam. The lower piece of foam overlapped the upper piece of foam, creating a small ledge as shown in Figure 4-15c. The positioning of the gerb was the same. The results were similar to the previous experiment; i.e., no ignition, just minor scorching and small holes in the foam from some of the sparks (see Figures 4-15c and 4-15d). The temperatures in the plume as a function of time are plotted in Appendix F, Figs. F-24 and F-25.

Figure 4-15. Gerb impinging fire retardant polyurethane foam (a); evidence of pitting (b); horizontal ledge at mid-plane to catch sparks, and evidence of scorching in second sample (c); and close-up of scorched area (d).

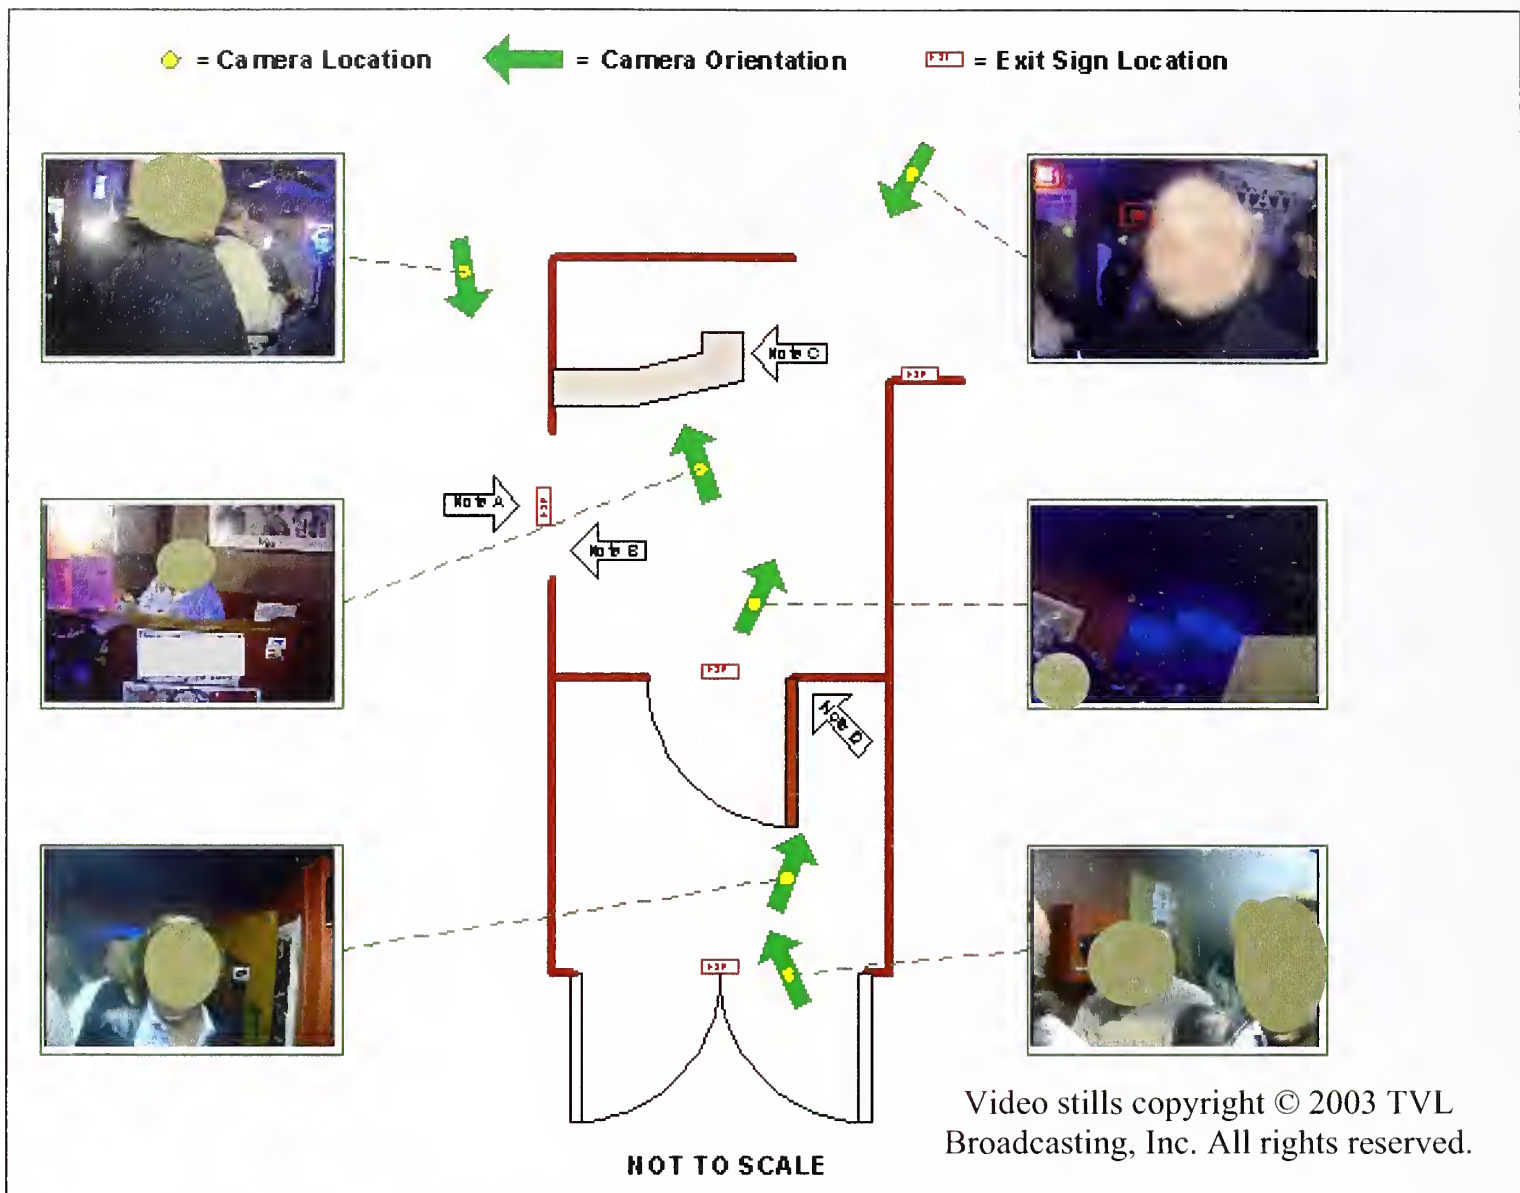
The precise event which led to the crowd-crush likely was related to the arrangement of the single interior door with merging streams of traffic and the pressure to escape the rapidly deteriorating conditions in the main area of the nightclub. Measurements of temperature, heat flux and gas species in a reconstruction of the platform area fire at NIST and computer models of the NIST experiment and the full nightclub suggest that the conditions around the platform, dance floor, sunroom, and dart room would have led to severe incapacitation or death within about 1-1/2 minutes after ignition of the foam for anyone remaining standing, and for not much longer even for those occupants close to the floor.

Figure 6-12. Detail of Main Exit Vestibule Area (Video frames copyright © 2003 TVL Broadcasting, Inc. All rights reserved)

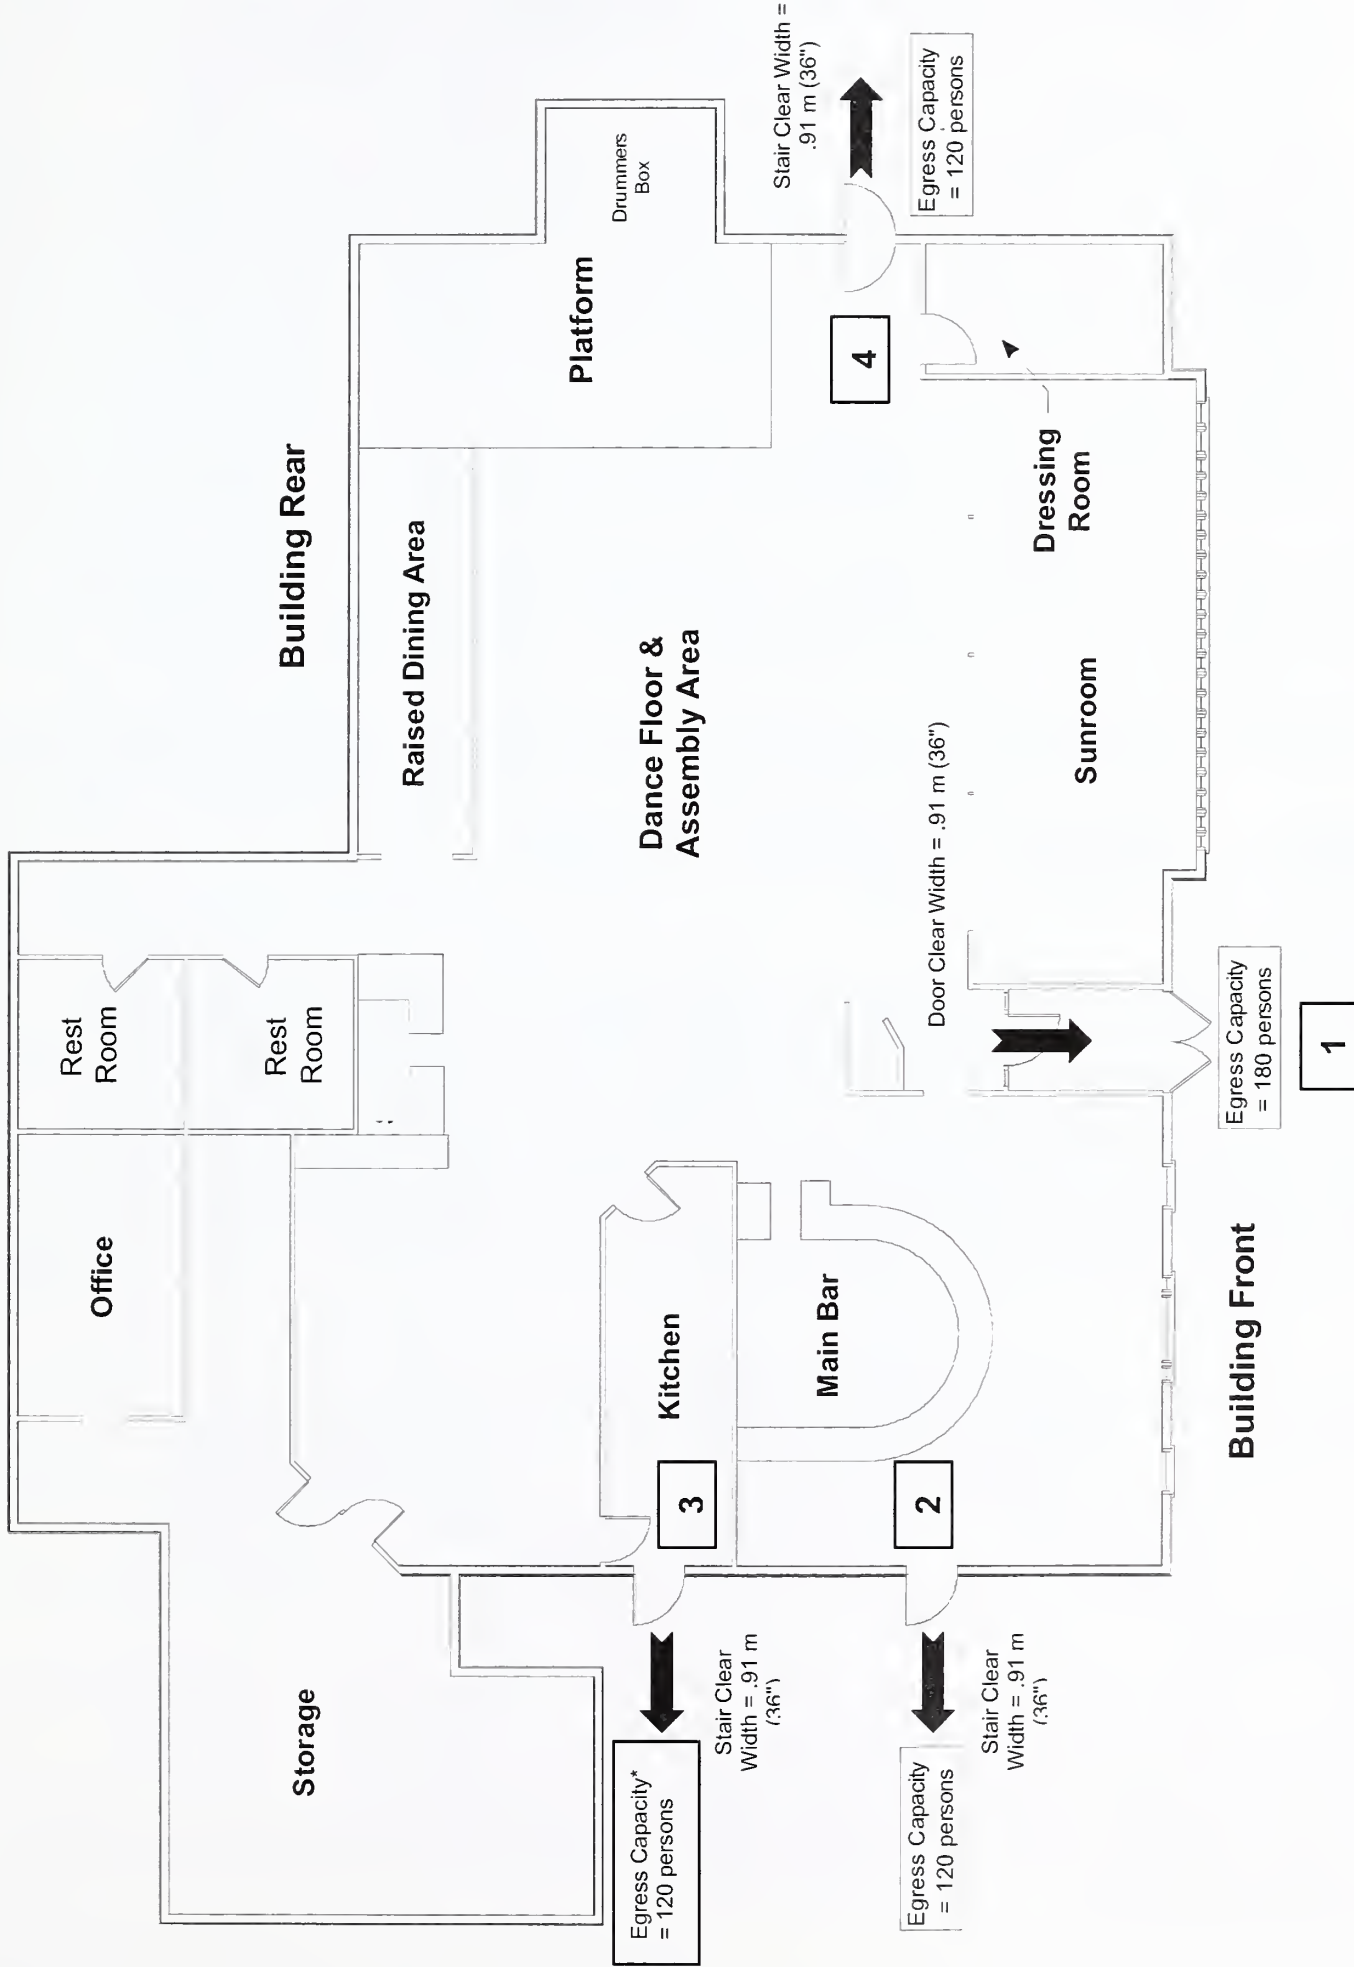
Figure 7-5. Station Nightclub Egress Capacity (*Note that model codes exclude exiting through a kitchen when calculating occupancy limit.)
